No Wear to be Seen

Creusabro 8000 exceeds expectations in Liebherr abrasion test programme

By Gilles Gros, product manager, IMS Group, and Nick Taylor, business development manager, IMS UK

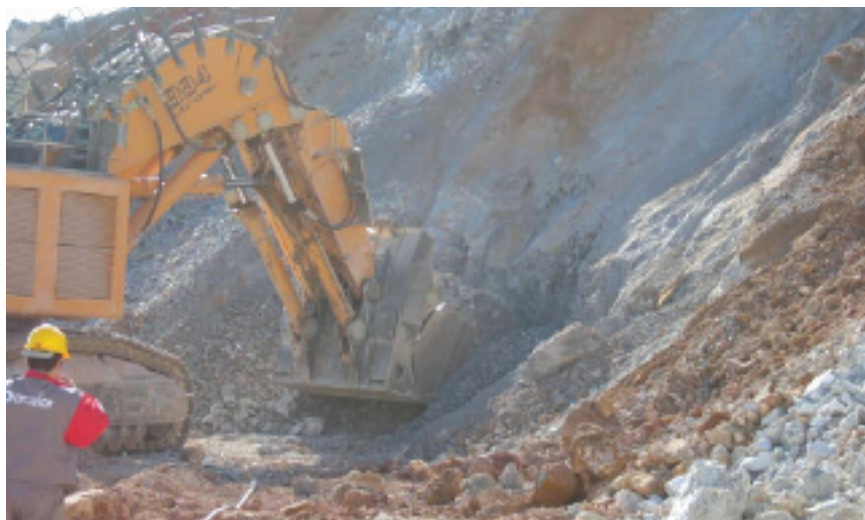
Test mining excavator bucket in use at the work face on a Liebherr ER 994B excavator

Two identical mining buckets were used for the test, both mounted on a Liebherr ER 994B – 771/14755 excavator. Both buckets were produced by Liebherr at their plant in Colmar, France, and were manufactured as two-part front shovel buckets with a mobile rear door for unloading the excavated material. The individual parts of both buckets were

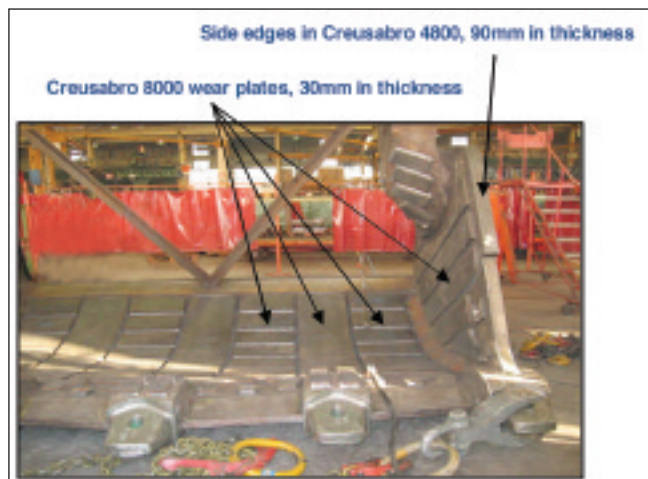
Test bucket no.1 produced from high-yield-strength steel with Creusabro wear plates welded into position

manufactured as shown in table 1.

Bucket parts	Material used for manufacture
Main body	High-yield-strength steel, 690MPa, 120mm thickness
Cross-section beams	High-yield-strength steel, 690MPa, 120mm thickness
Blades (cutting edge)	High-yield-strength steel, 690MPa, 200-250 HB
Fixing parts and teeth adapters	Cast steel
Side edges	Creusabro 4800 steel, 90mm thickness
Wear parts – mining bucket No.1	Creusabro 8000 steel, 30mm thickness
Wear parts – mining bucket No.2	400/500 HB steel (Liebherr original)

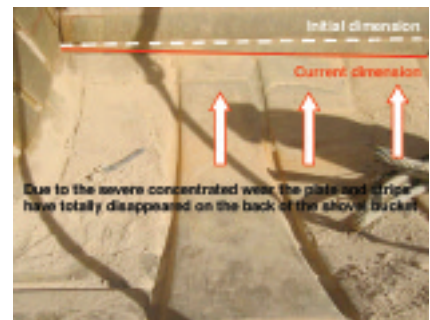
View showing the serious wear effect in the centre of the shovel bucket. Measurements were not possible on the plate and strips due to the severity of the wear

- The level of wear found in the shovel bucket was very serious due to the abrasion effect from the continual throughput of the excavated material from the working face.
- Owing to the concentrated wear at the back of the shovel bucket, due to the weight and momentum of the high tonnages of material being extracted

and dumped, the wear-protection strip extremities were totally worn away on the back of the bucket and could not be measured.

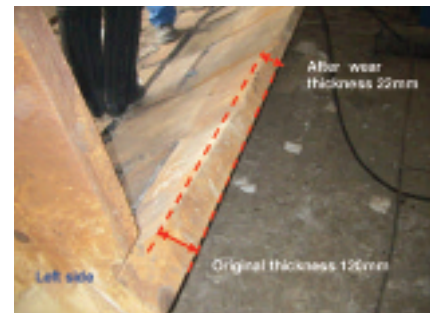
Measuring the wear effect from left to right on the back of the shovel bucket

- Measurements taken showed the thickness of the beam (originally 120mm) had been reduced to 22mm as a result of the abrasive effect of the extracted mineral on the steel.
- Other consequences observed as a result of the continual wear on the inside faces of the bucket were loss of mechanical resistance and distortion leading to risk of rupture and the need for critical maintenance. However, no repairs were required on the outside surfaces.

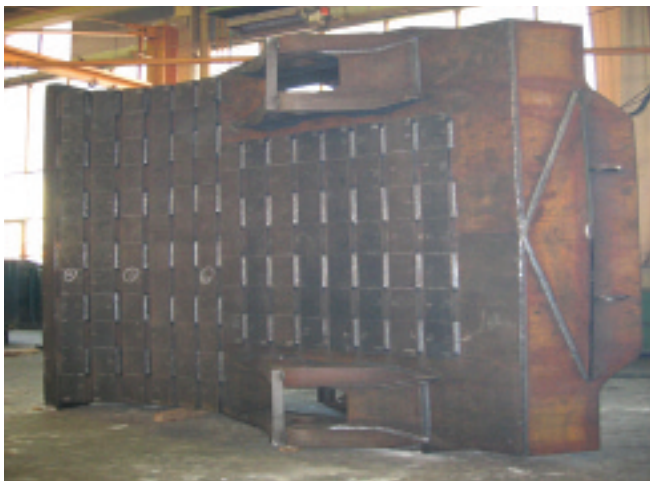
Beam on the back static part of the test bucket manufactured from a high-yield-strength steel, 120mm in thickness

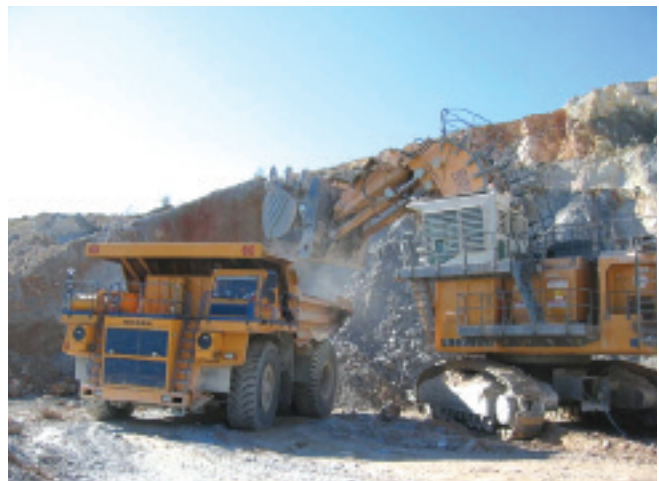
Bucket no. 1

Mining bucket no.1 – the IMS Group Creusabro 8000 wear parts-equipped test bucket – was utilized from October to March throughout the more severe wet season, which included rain, snow and extremely low temperatures. The bucket was used for 2,600h and, on inspection, required no maintenance or refurbishment at that time. It went on to operate for a total of 3,700h at which point minor refurbishment was required, which was primarily cleaning.

- Despite the longer working hours and more extreme conditions, the Creusabro 8000 significantly reduced the level of abrasion and wear, thus preserving the integrity of the shovel bucket and allowing it to operate to its full potential.

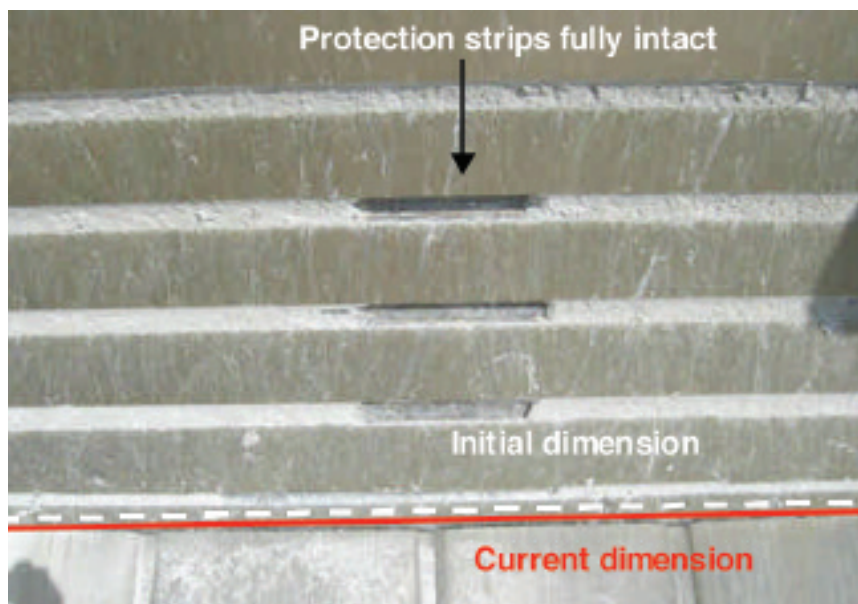
No visible dimensional difference between the initial and final alignment and all protection strips down the side of the static back of the bucket are fully intact

- The wear protection strips on the static back of the shovel bucket were all in good condition.
- There was no visible dimensional difference between the initial alignment on the back of the shovel bucket and the post-test alignment.

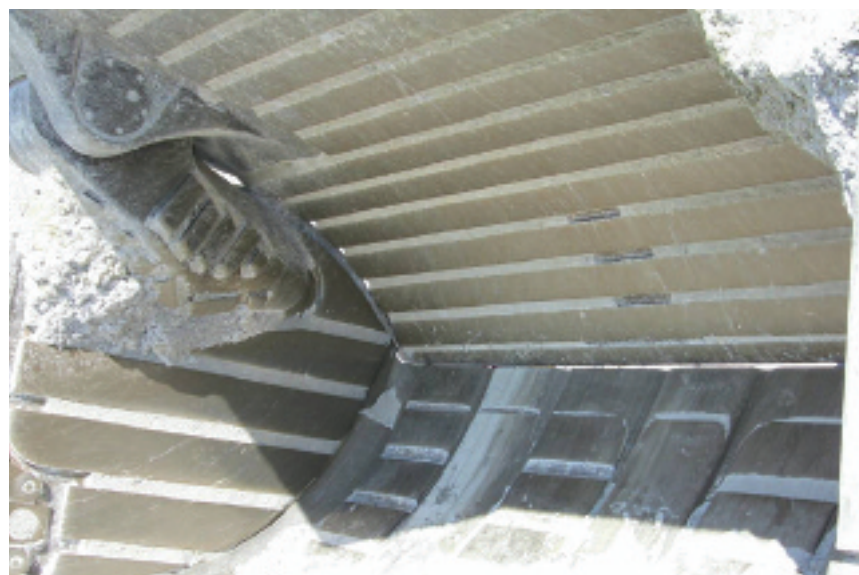
Minimal wear has occurred during the test programme retaining the integrity of the bucket operation. Small grooving in the structural base of the bucket can be seen

- Some grooving in the structural base of the bucket was observed, due to the weight and momentum of the high tonnages of material being extracted and dumped, but the level of maintenance required was minimal.
