Wear parts pass the test

Following a comparative abrasion test program, run in conjunction with IMS Group over 12 months in extreme mining conditions, Liebherr Group is now offering customers the opportunity to purchase face shovels and excavator buckets equipped with Creusabro 8000 wear parts which have been proven to increase the wear life of the mining buckets by over 46%. Gilles Gros, product manager at IMS Group and Nick Taylor, business development manager, IMS UK, explain.

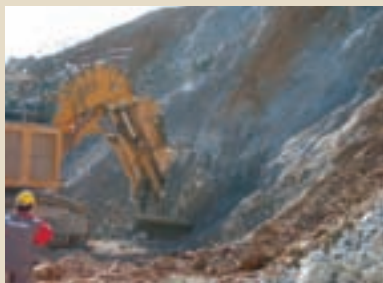
Test mining excavator bucket in use at the work face on a Liebherr ER 994B - 771/14755 excavator

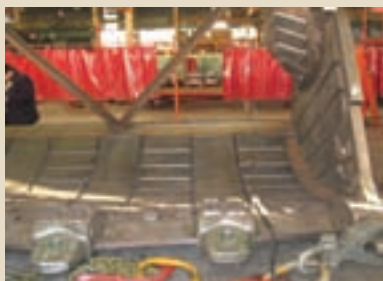
Test bucket no.1 produced from high yield strength steel with Creusabro wear plates welded into position

The wear parts for mining bucket number 1 were made from Creusabro 8000 steel, 30 mm thick. For Liebherr's original was mining bucket number 2, made from 400/500 HB steel.

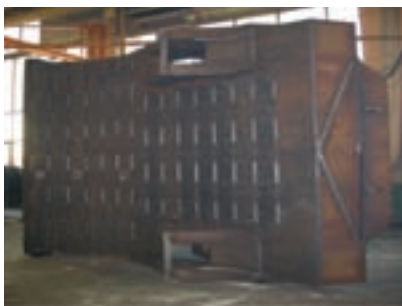
The test program monitored the thickness of these three strips

To assess the overall difference in performance the testing schedule monitored the wear parts' thickness over a period of time as well as the thickness of the cross-sectional beam on the static back of the bucket manufactured from the standard high yield strength steel. The tonnages of material moved over the same time period were also monitored.

The wear protection strips on the static back of the shovel bucket were all in good condition. The strip measurements were easily made and showed the abrasion resistant steel had performed well compared with the standard water quenched 400/500HB resistant part, with minimal wear being recorded.

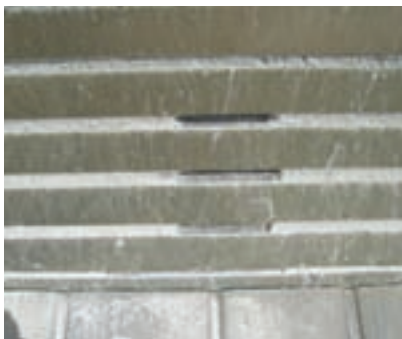
No visible dimensional difference between the initial and final alignment, and all protection strips down the side of the static back of the shovel bucket are fully intact

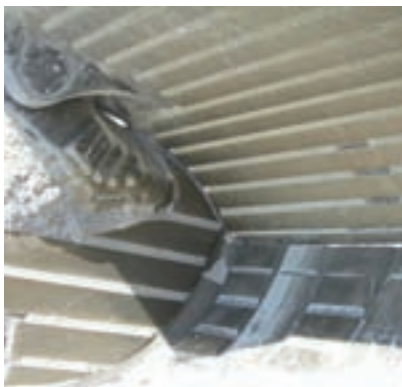
Minimal wear has occurred during the test program retaining the integrity of the bucket operation. Small grooving in the structural base of the bucket can be seen

Some grooving in the structural base of the bucket was observed but the level of maintenance required was minimal.

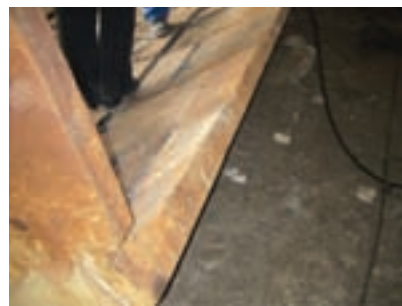
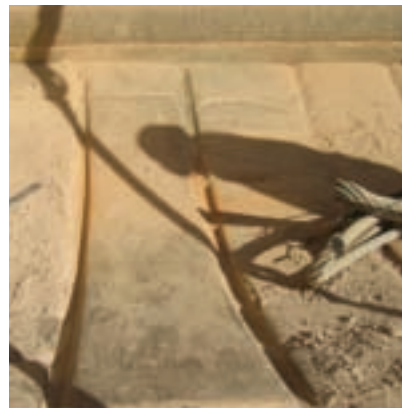
View of the serious wear effect in the centre of the shovel bucket. Measurements were not possible on the plate and strips due to the severe wear

Due to the concentrated wear at the back of the shovel bucket the wear protection strip extremities were totally worn away and could not be measured

The beam's original 120 mm thickness was reduced to 22 mm in thickness following the abrasion effect on the extracted mineral on the steel.

Other consequences observed from the continual wear on the inside faces of the bucket were loss of mechanical resistance and distortion leading to risk of rupture and critical maintenance requirements. However no repairs were required on the outside surfaces.
